## 720 HOOD AVE SHINNSTON, WV SCOPE OF WORK

**Project Title:** Royal Chrysler Site Study – 25062.01

**Prepared By:** David Crupe – McKinley Architecture & Engineering

Re: ADS File No.: MCKINLEY-25-02  
Royal Chrysler Building Collapse  
Structural Observation Report

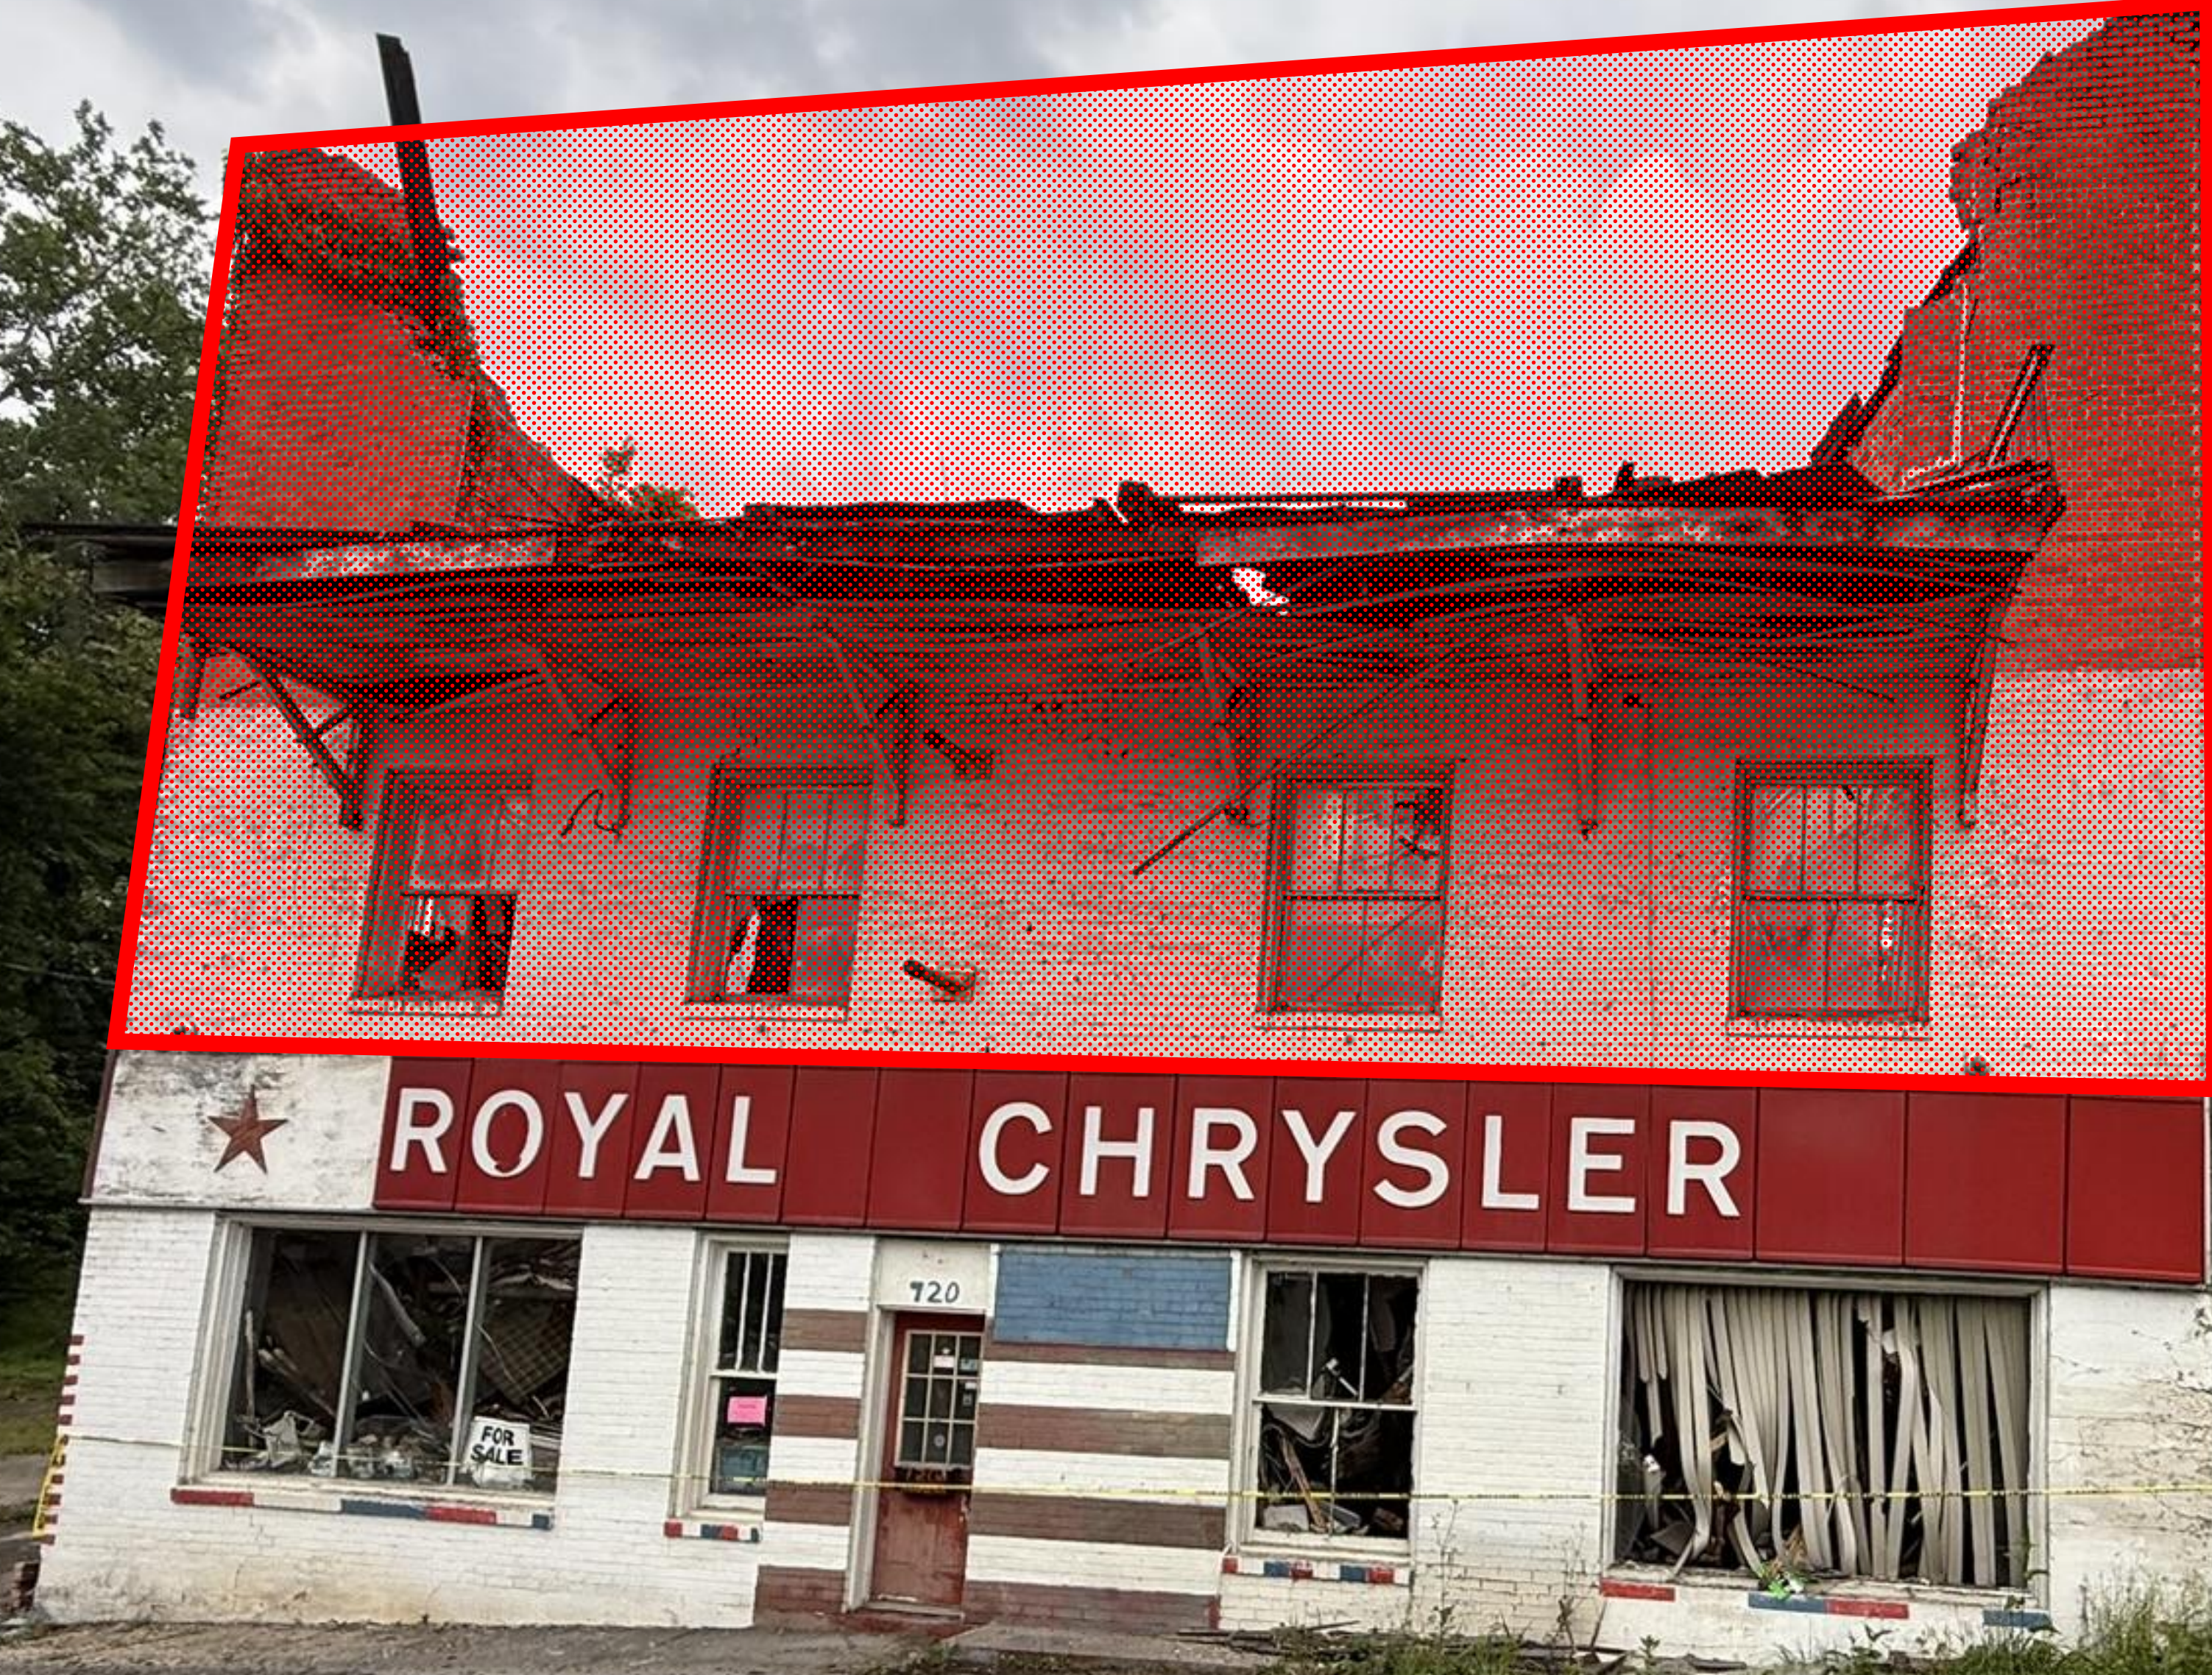
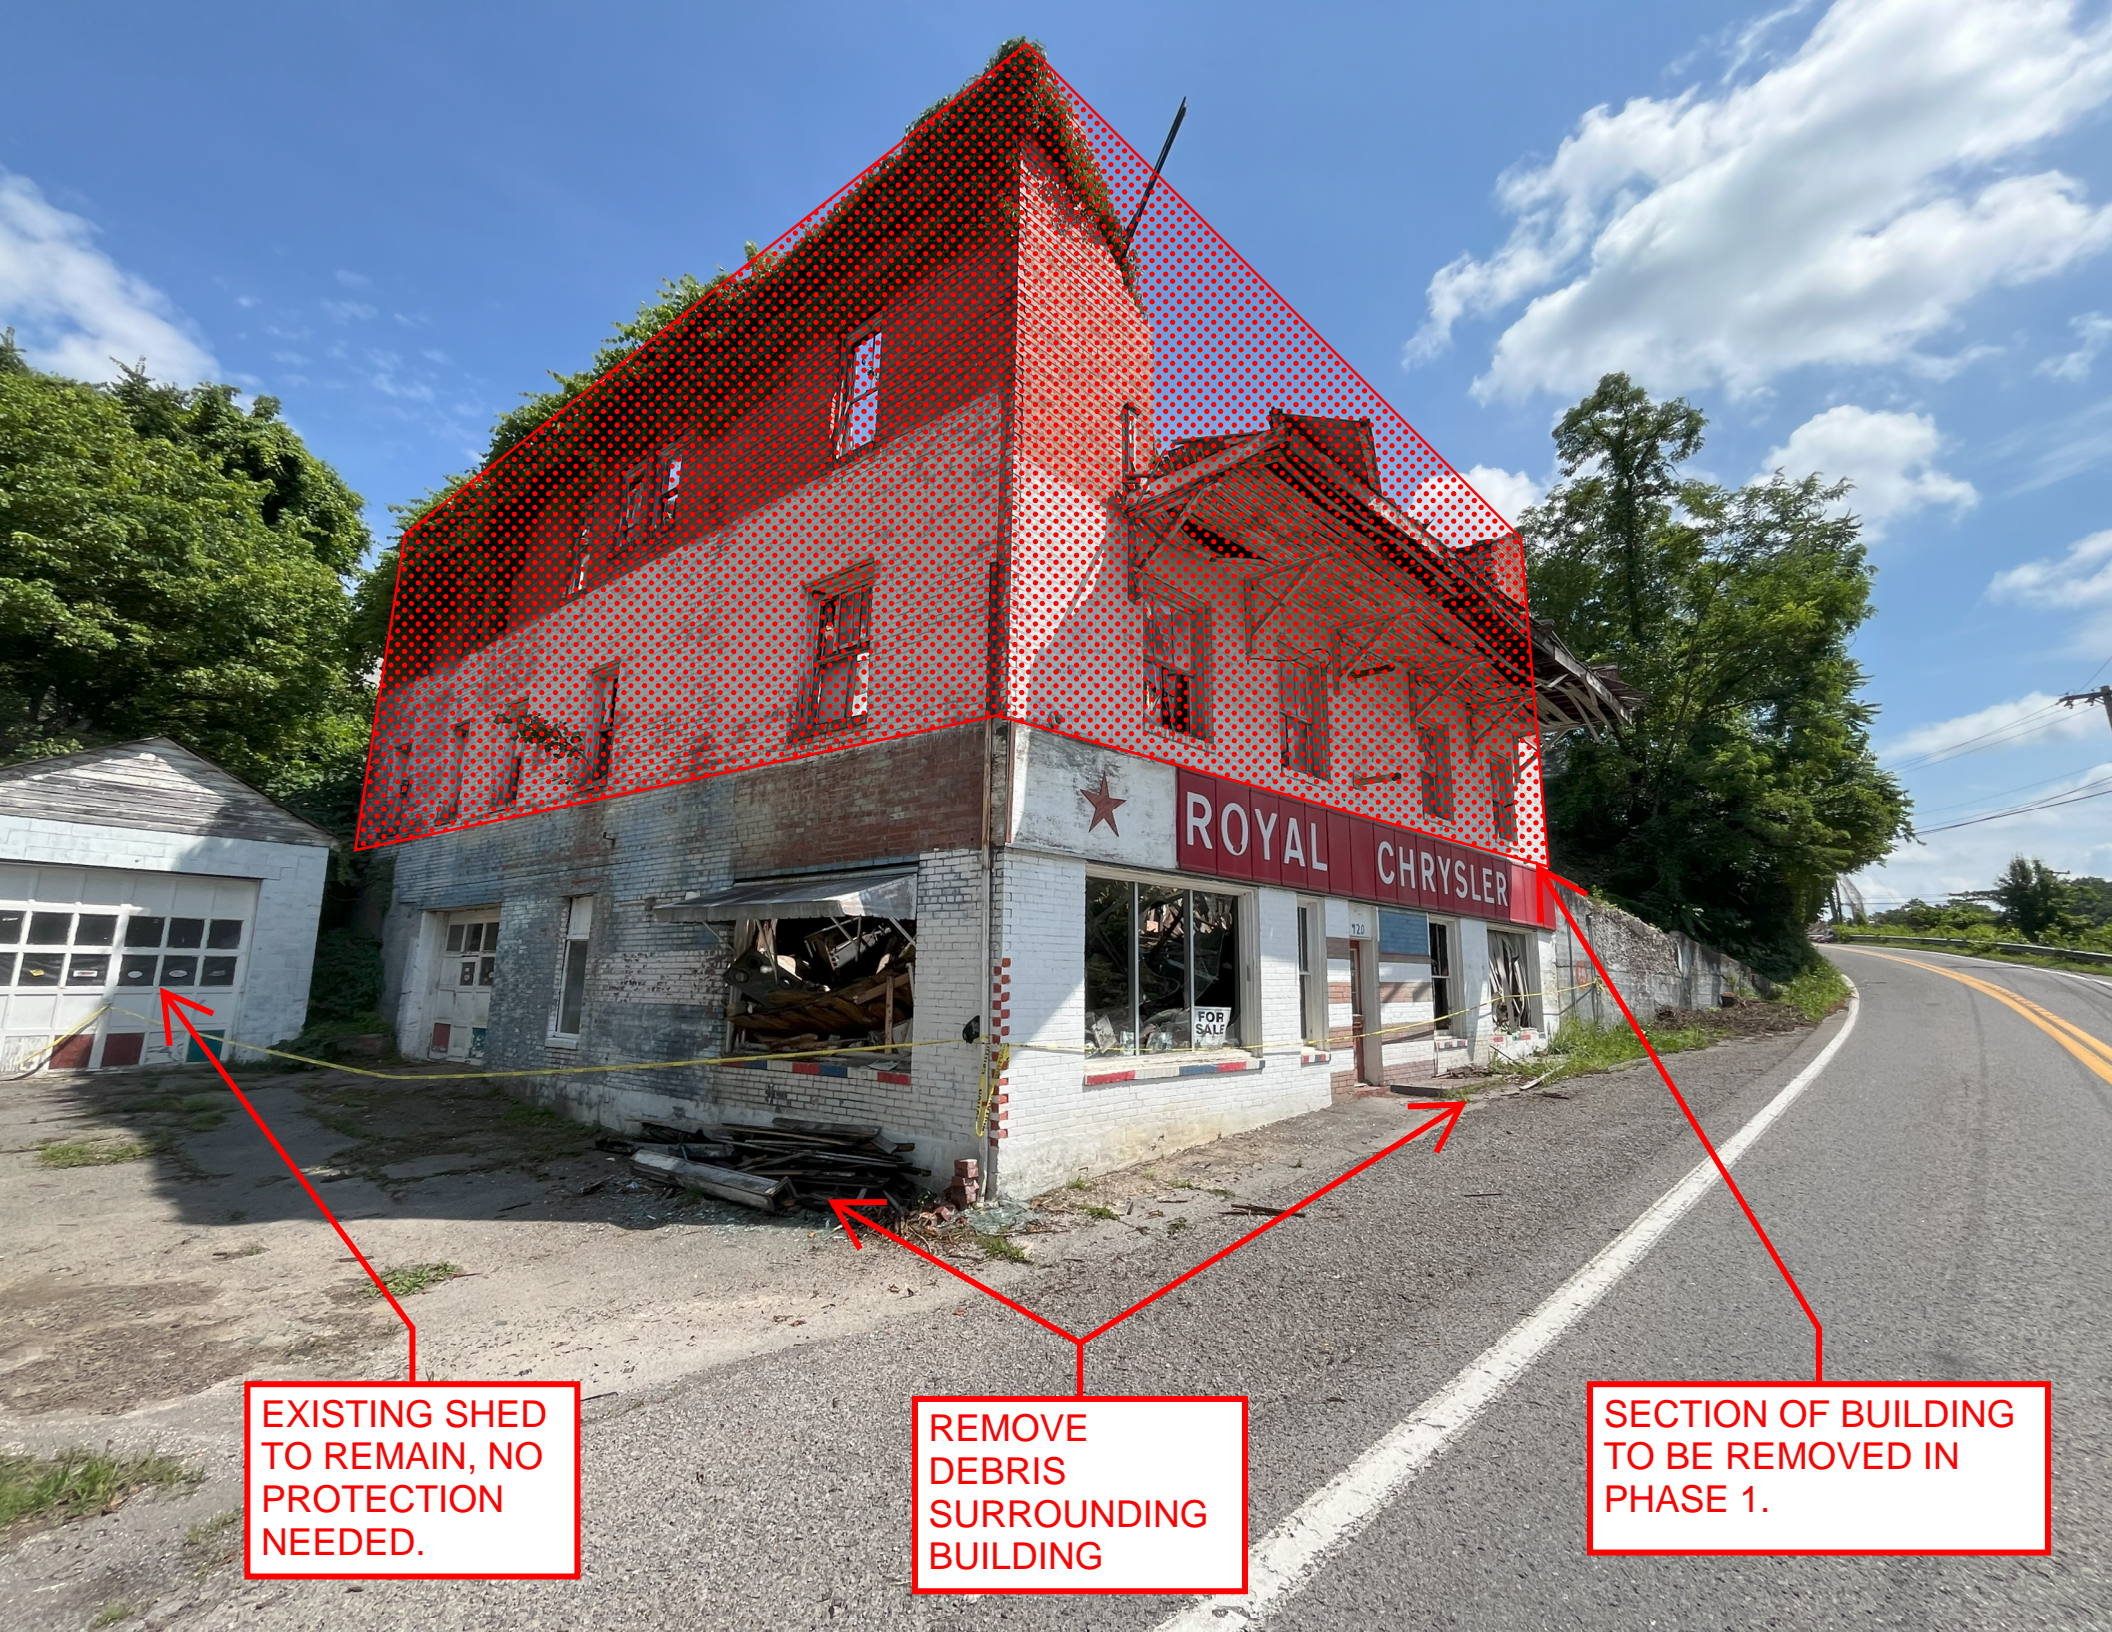
SECTION OF  
BUILDING TO BE  
REMOVED IN  
PHASE 1.

EXISTING SHED  
TO REMAIN, NO  
PROTECTION  
NEEDED.

REMOVE  
DEBRIS  
SURROUNDING  
BUILDING

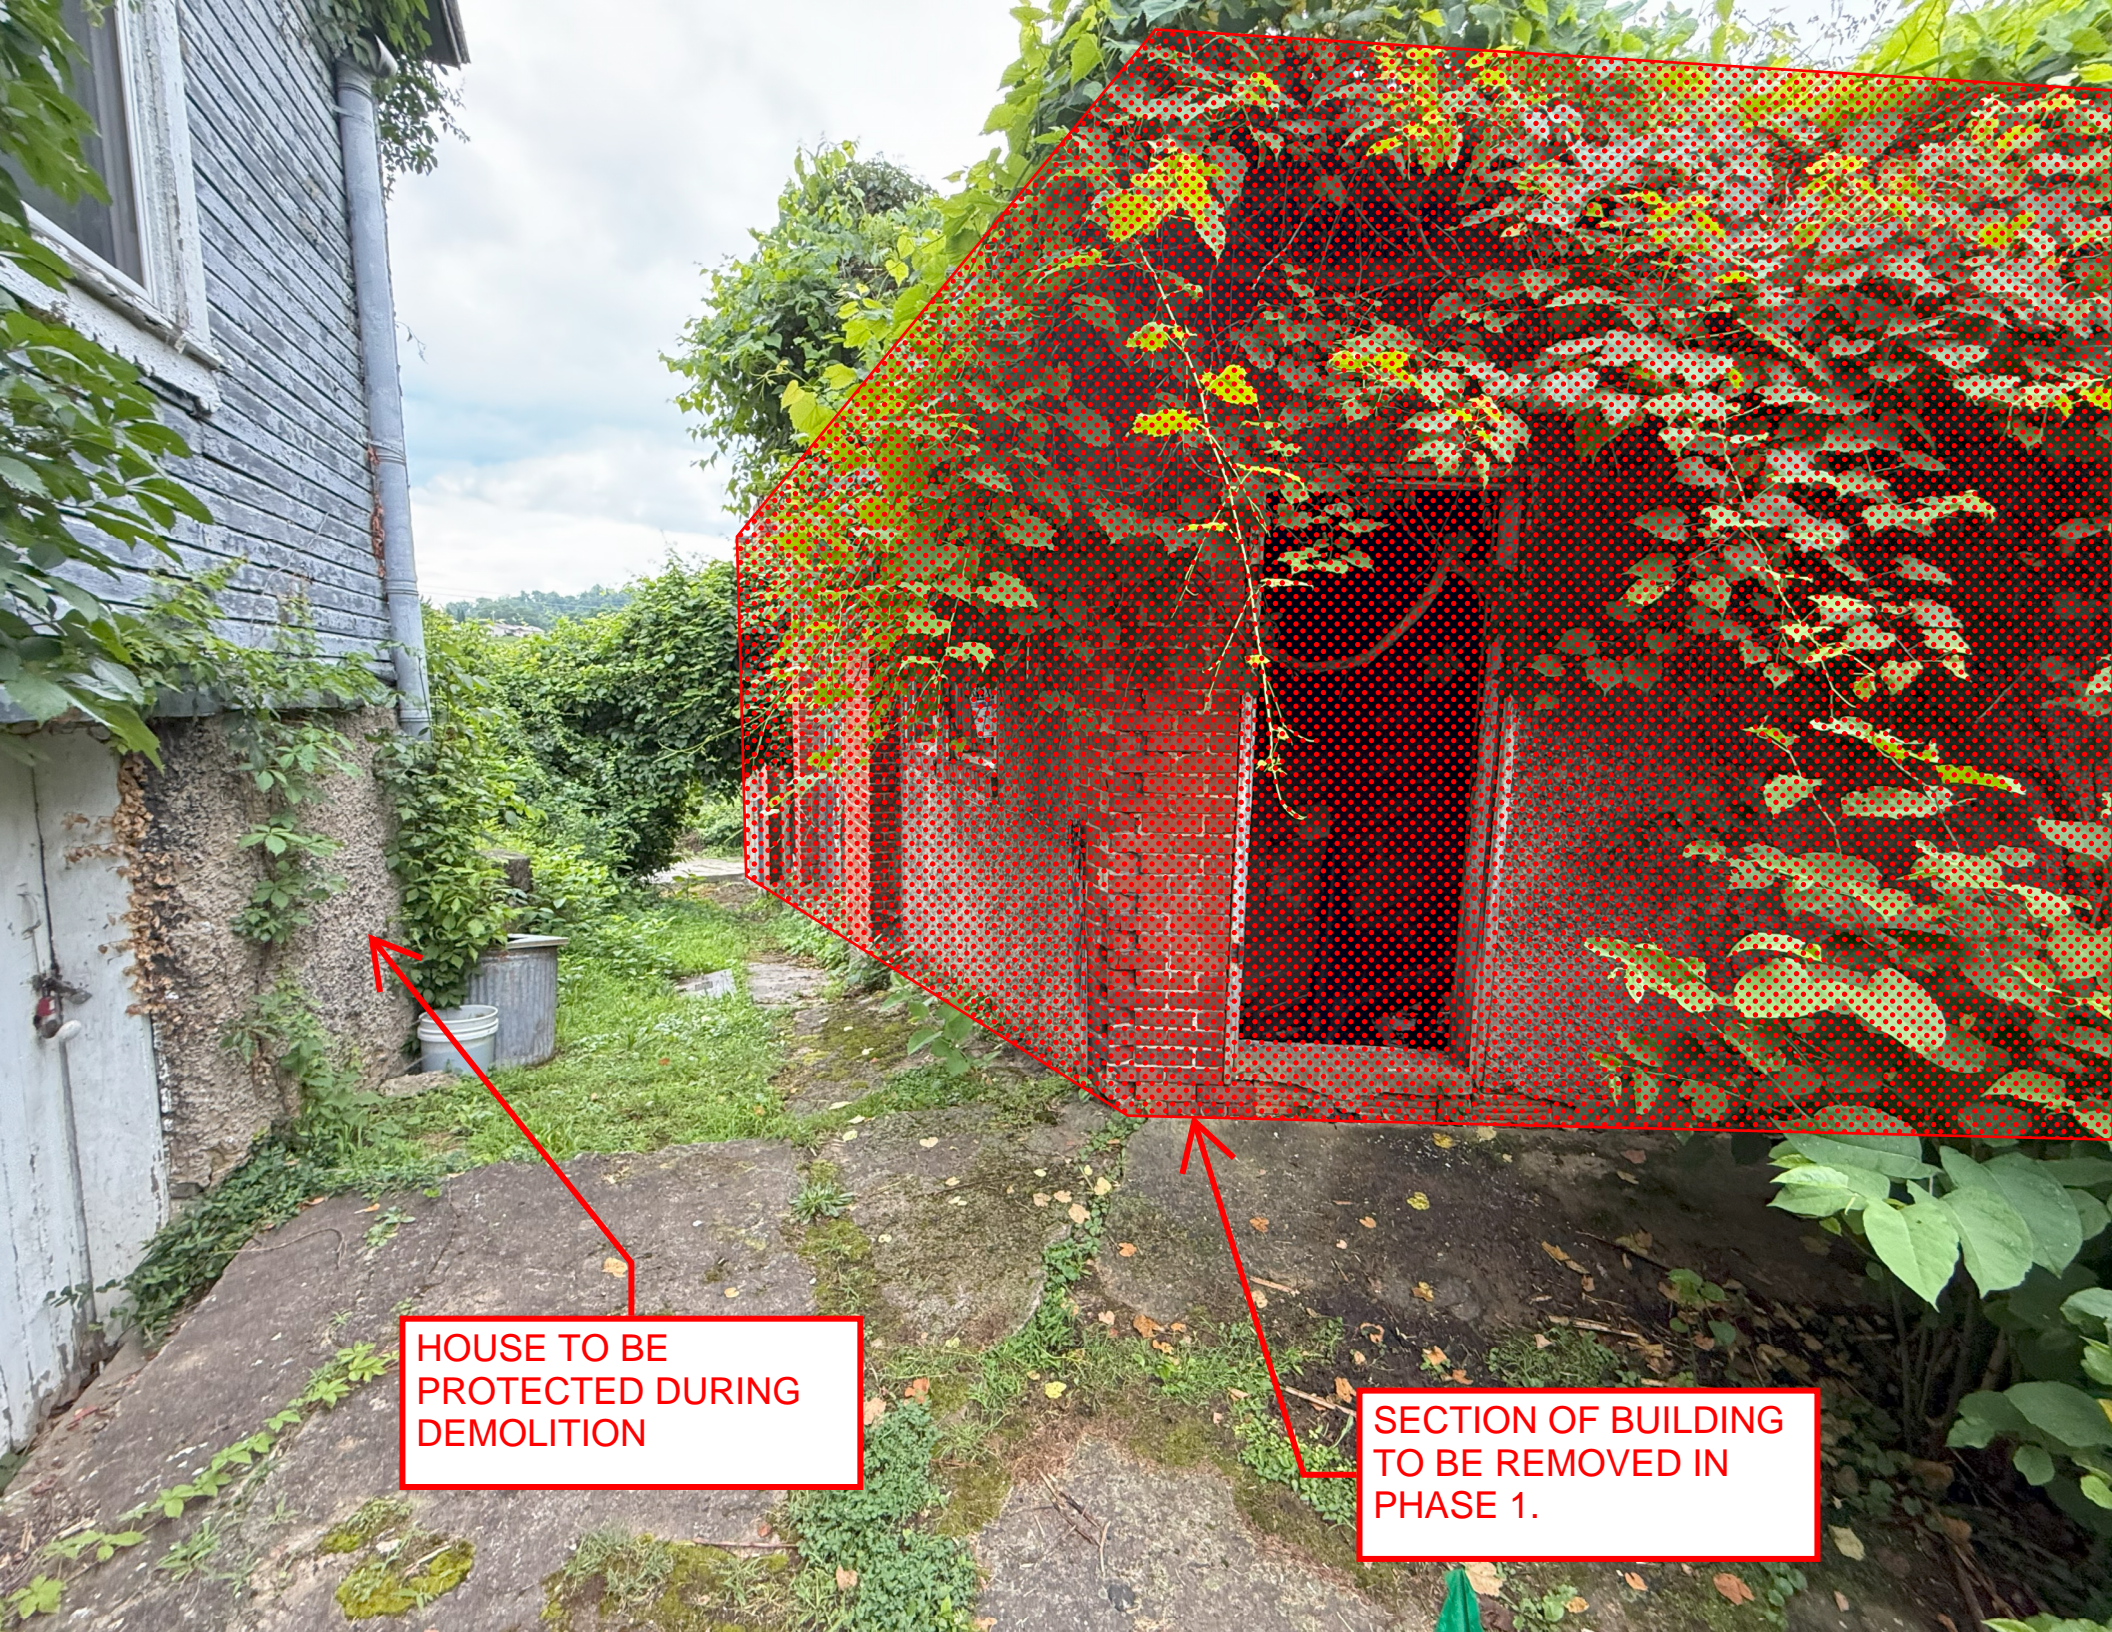
SECTION OF BUILDING  
TO BE REMOVED IN  
PHASE 1.

HOUSE TO BE  
PROTECTED DURING  
DEMOLITION

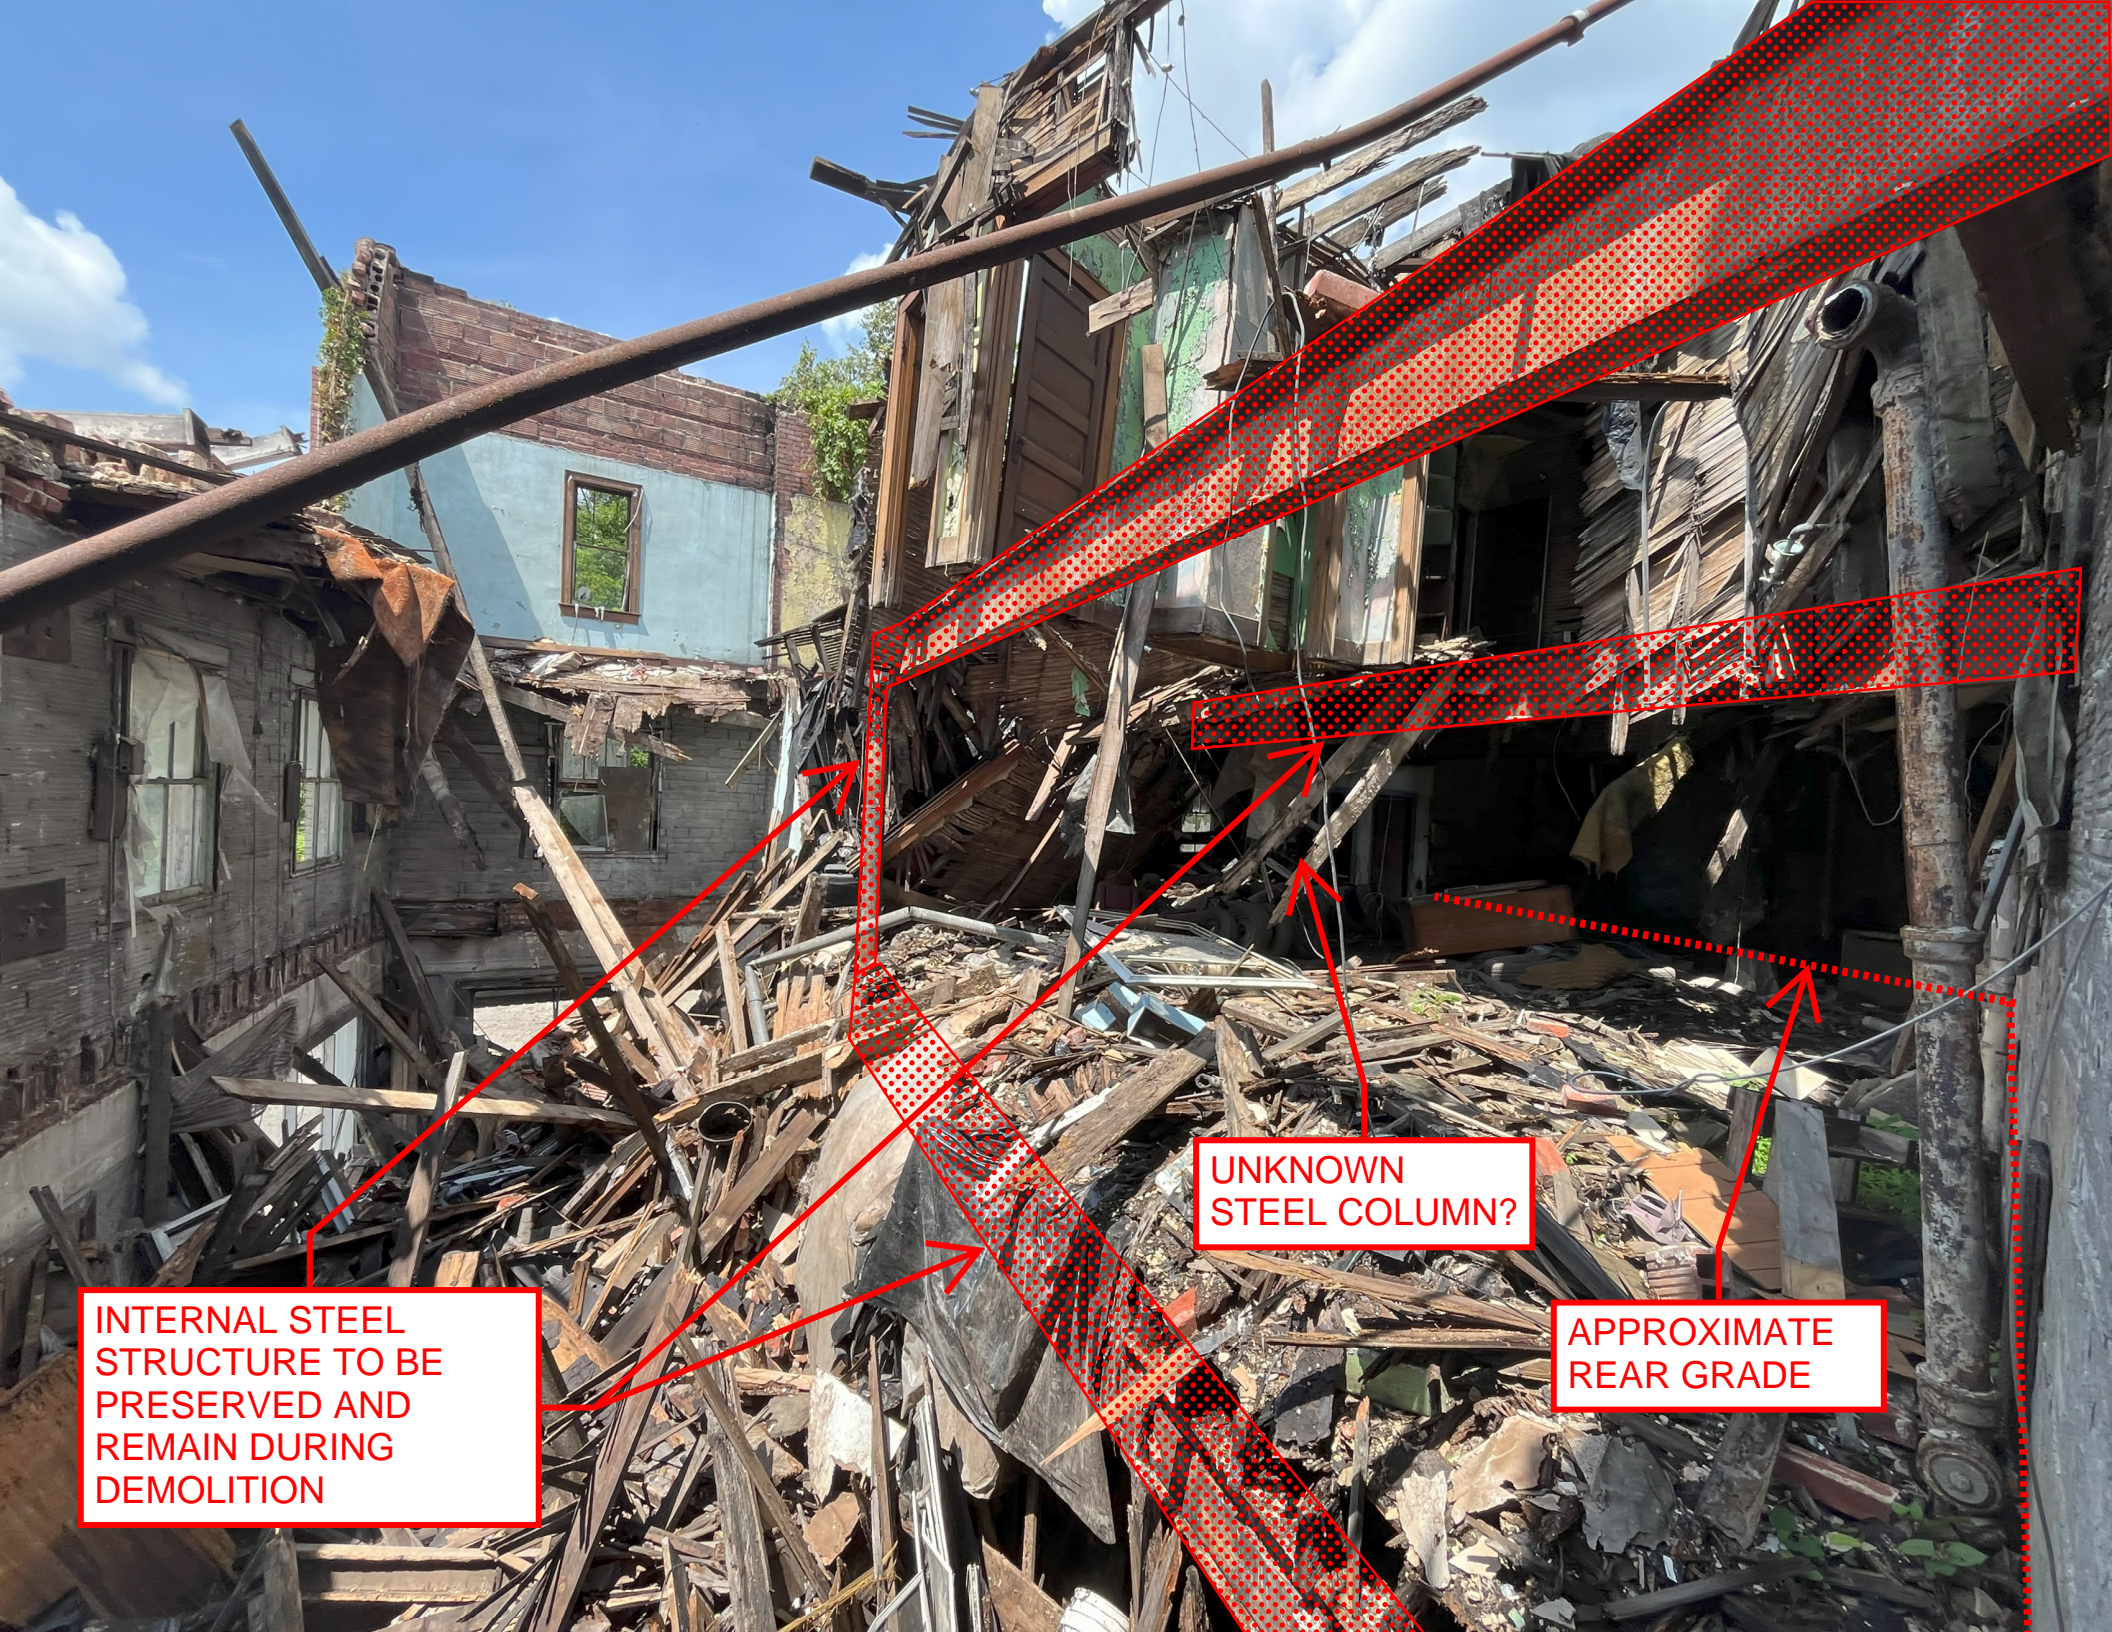
SECTION OF BUILDING  
TO BE REMOVED IN  
PHASE 1.

INTERNAL STEEL  
STRUCTURE TO BE  
PRESERVED AND  
REMAIN DURING  
DEMOLITION

UNKNOWN  
STEEL COLUMN?

APPROXIMATE  
REAR GRADE

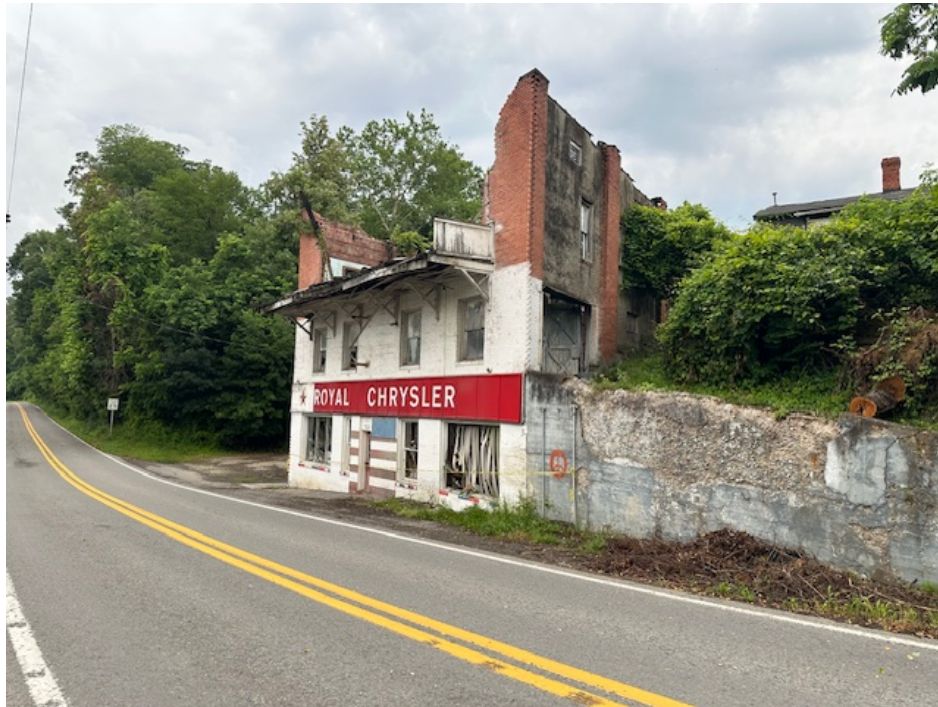
A field investigation was performed on 6/27/2025 at the Royal Chrysler Building located at 720 Hood Ave., Shinnston, West Virginia. The field investigation was performed to assess the collapsed building's potential risks to the adjacent house above the hill and the road in front. See Photo 1 in Exhibit A for the overview picture of the front of the building. The top of the adjacent house above the collapsed building can be seen in photo 1 and the space between the buildings can be seen in photo 2.

1. The roof and second floor framing have been almost completely fallen to the ground level.
2. There is apparent water damage to the framing members that could be seen, which contributed to the deterioration of the building.
3. The basement wall of the building that retains the grade up to the adjacent blue house no longer has the second floor or roof structure bracing it. See Exhibit B for photos from the back door of the building into the collapsed structure. These photos show that the second floor is no longer bracing the basement wall.
4. The wall at the time of the field investigation did not show signs of structural failure.

The collapsed building is not repairable and needs to be demolished. The concern during demolition is the structural stability of the hillside above and more importantly the adjacent house above the collapsed Chrysler building. We recommend that a Civil and/or Geotechnical engineering company provide a plan to stabilize the hillside during and after the demolition process.
